Normal Ultrasound Findings and Complications of Breast Implants in Colombia

Hallazgos ecográficos normales y complicaciones de implantes mamarios en Colombia

Valentina Múnera Orozco¹
Ximena Saldarriaga Jaramillo²
Catalina Mejía Soto¹

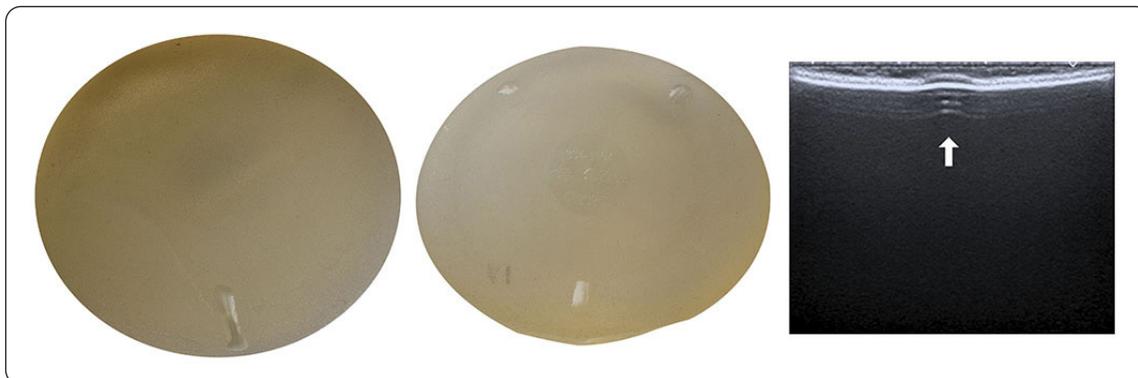
Figure 1. Mentor anatomical prosthesis. In the image on the right, the marking is seen on the inferior pole of the anterior face, vertical and linear. In the image on the left, the posterior seal in the center and two round badges on the upper pole and another vertical one on the lower pole. Ultrasonographically they are observed as a small curve with a double reflective line. It serves as an intraoperative guide to avoid rotation.

1.2.3. Periprosthetic liquid. It can be in variable quantity, it is physiological. It should be an anechoic liquid like water, without internal echoes or septa. It is believed to be the result of an inflammatory response and is not indicative of rupture (12) (figure 1).

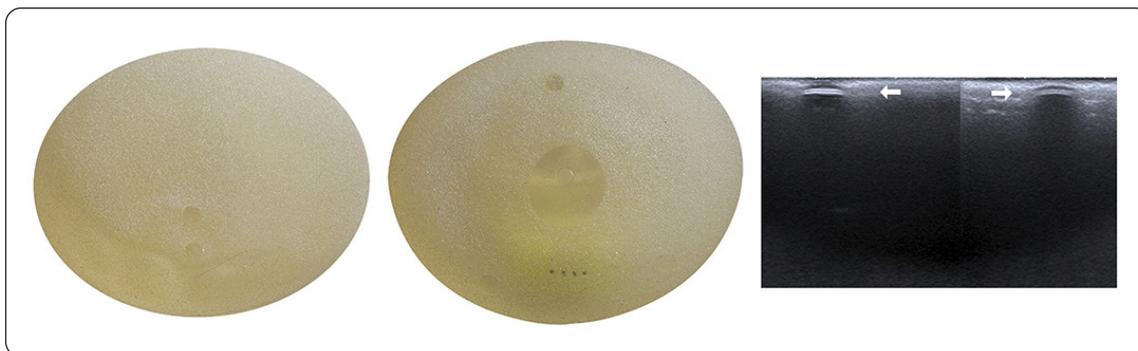
Figure 2. Anatomic prosthesis, McGhan brand. In the image on the right, there are two round distinctive features in the inferior pole and anterior face that are represented ultrasonographically in the upper image as two small curves of about 5 mm with a double reflective line. In the left image, the posterior seal as a thickening of the capsule or a single horizontal echogenic subcapsular line that is sonographically represented in the lower image.

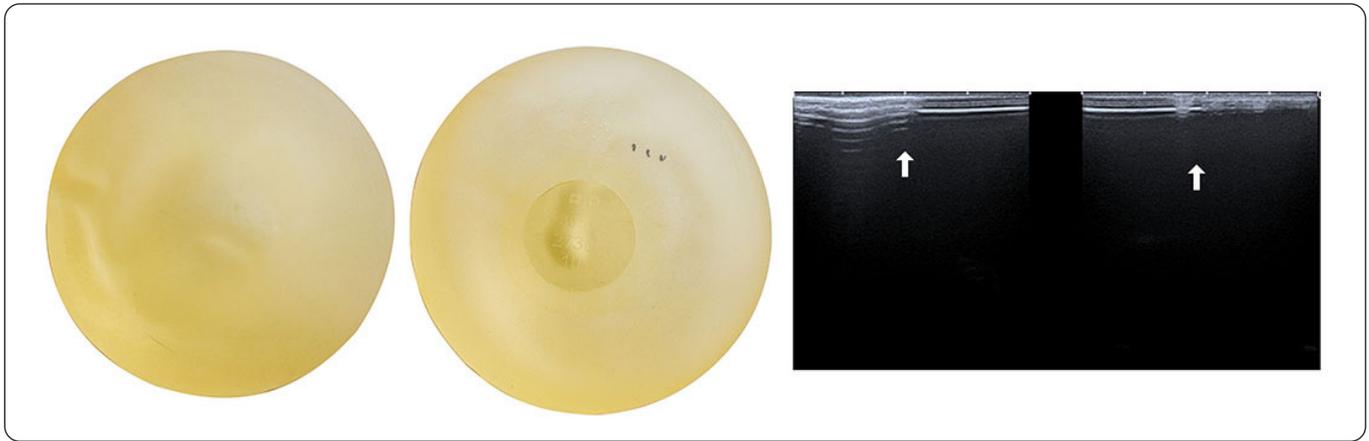
Figure 3. Round prosthesis, PIP brand, does not present distinctive features in its anterior face, but the posterior seal or tag is present. Ultrasonographically it appears as an echogenic line parallel to the implant capsule, incomplete or a “posterior thickening” of the implant shell.

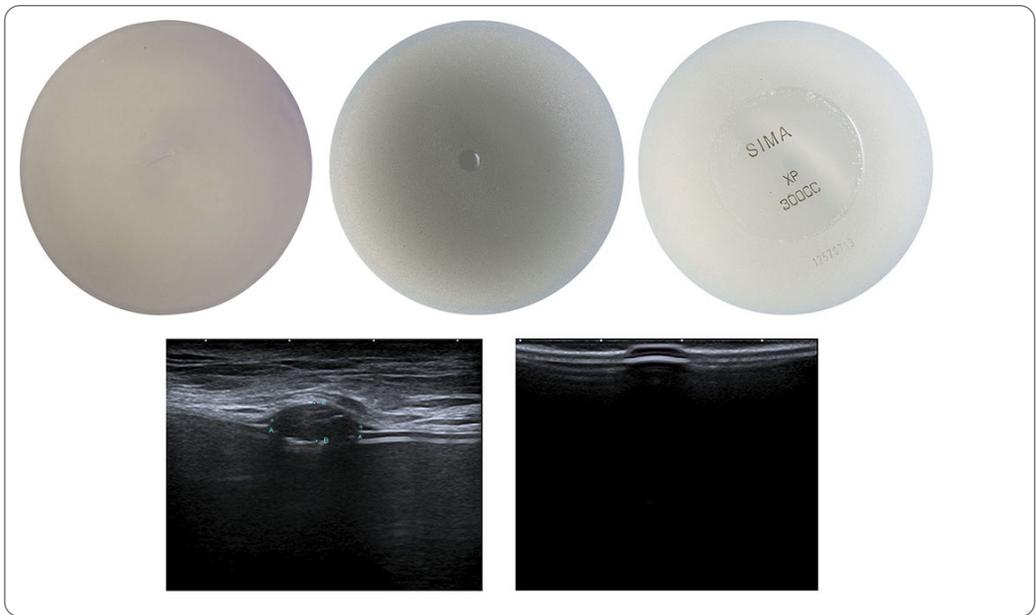
Figure 4. Round prosthesis, SIMA brand, presents two different forms of anterior markers, round and small. Ultrasonographically it is observed in the left image as a widening of the double reflective line with a pseudocystic anechoic center and in the right image as a small curve of about 5 mm with a double reflective line.

The sonographic finding is an incomplete subcapsular echogenic line of variable length from 1 to 4 cm, and should not be confused with a capsular detachment due to a rupture (Figure 8). It can also be observed as a disruption of the capsule associated with an oval or small semicircles that protrude anteriorly (14) (figure 4).

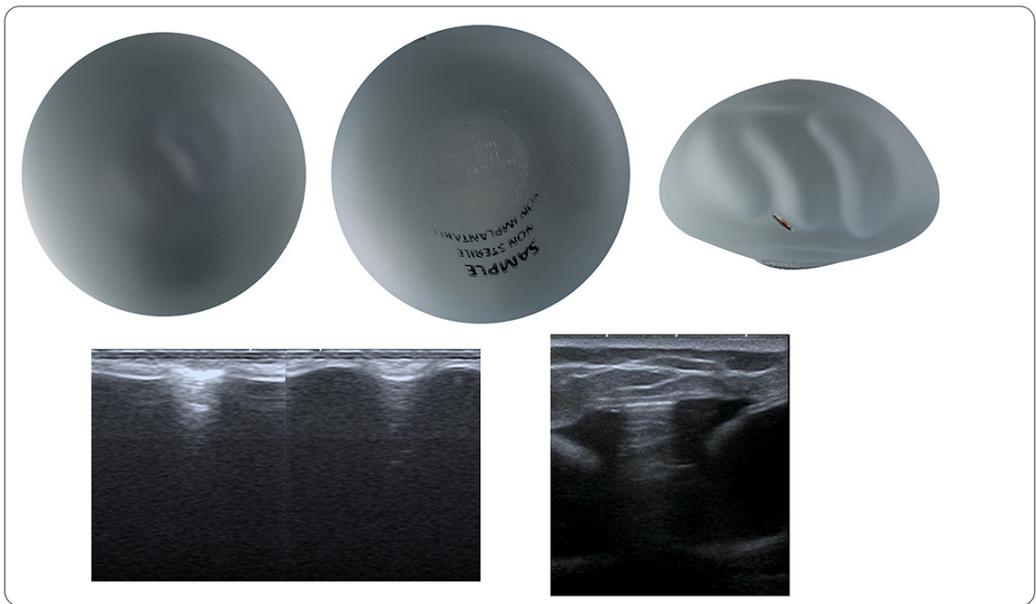
Figure 5. Round prosthesis, Motiva brand, has a chip in lateral face. Ultrasonographically it is identified as a hyperechogenic image that generates reverberation compatible with the chip (the lower right image corresponds to a patient with this implant).

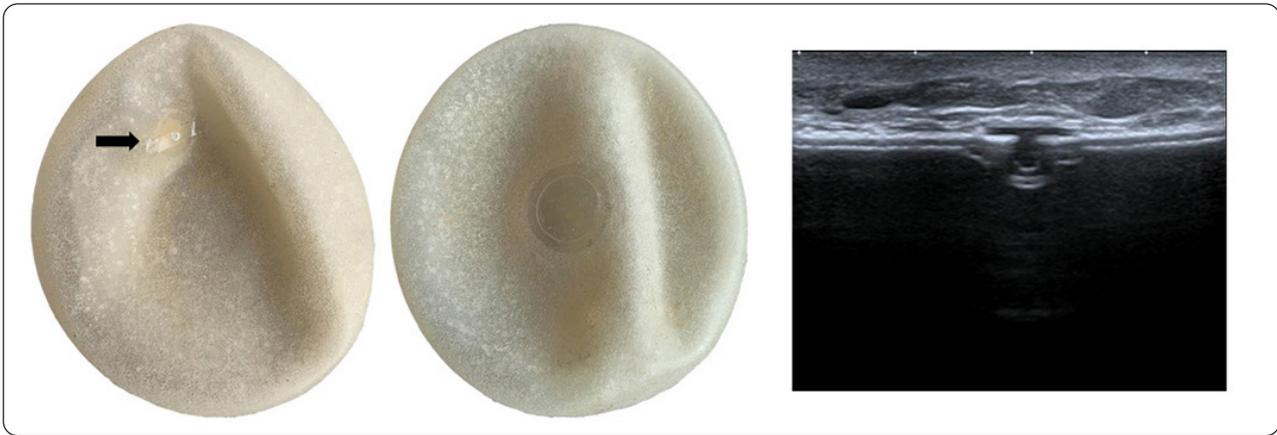
Figure 6. Saline solution prosthesis. Ultrasonographically it shows an anechoic line anterior to the implant capsule of 5 mm length and a small inverted curve of about 6 mm with a double reflective line that represents the implant valve (black arrow).

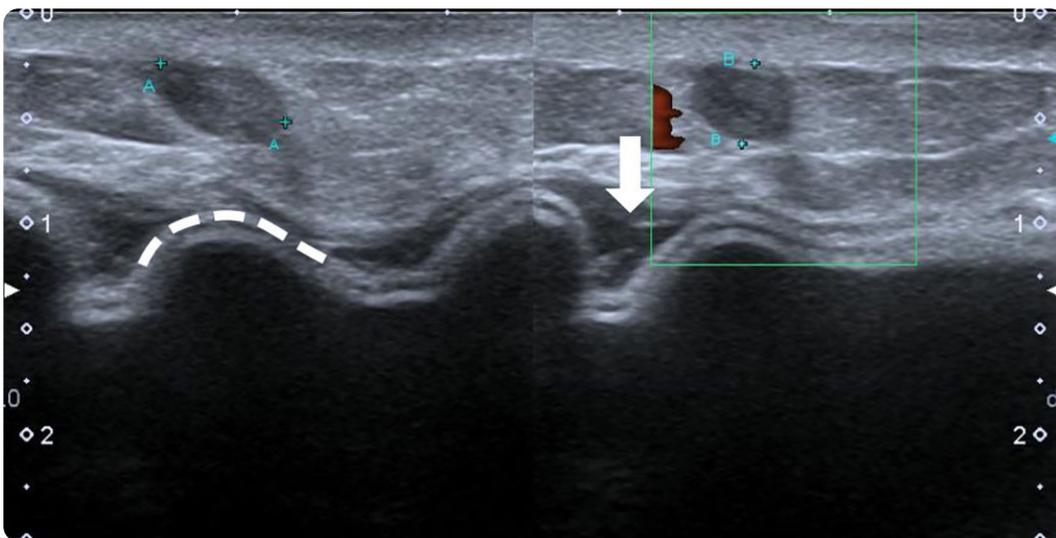
Figure 7. An implant with prominent radial folds (in white dashed line) is observed ultrasonographically. In this image it is possible to see the fibrous capsule that is separated from the implant capsule by anechoic periprosthetic liquid (white arrow).

1.2.1. Folds, lobulations or invaginations. The image is variable and is produced when the surface of the implant wrinkles during positioning in a pocket created by the surgeon, either subglandular (prepectoral) or subpectoral (under the pectoralis major muscle). They are echogenic wavy lines that are known as radiated folds, without associated capsular thickening, stiffness, periprosthetic fluid, or pain referred by the patient (5) (figure 7).

biological response to a foreign body. The capsule can thicken or calcify with time and is more easily recognized when there is periprosthetic liquid (10,13) (figure 7).

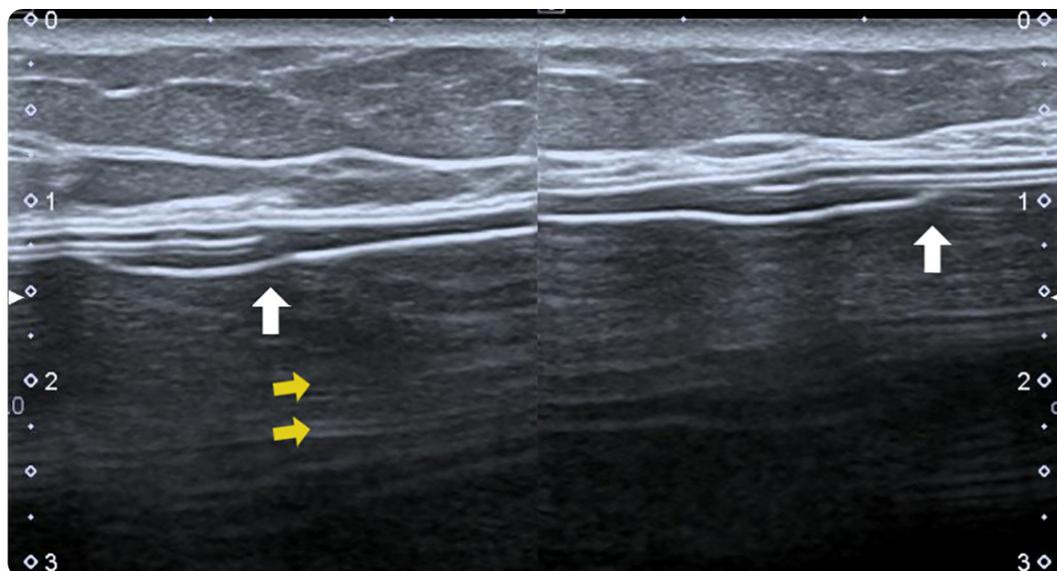
Figure 8. Echogenic images that occupy in a linear and horizontal way all the proximal and superficial field of the image, by normal reverberation (yellow horizontal arrows). In addition, in the anterior region of the implant the posterior marking is observed (white arrows) consistent with implant rotation.

1.2.2. Reverberation. They are echogenic images that occupy in a linear and horizontal way all the superficial field of the echographic image, by reverberation of the sound through the capsule. They depend on the thickness and calcification of the implant capsule (of the silicone elastomer), the density of the silicone and the resolution of the ultrasound. They do not indicate rupture of the implant and are a normal finding (5, 9) (figure 8).

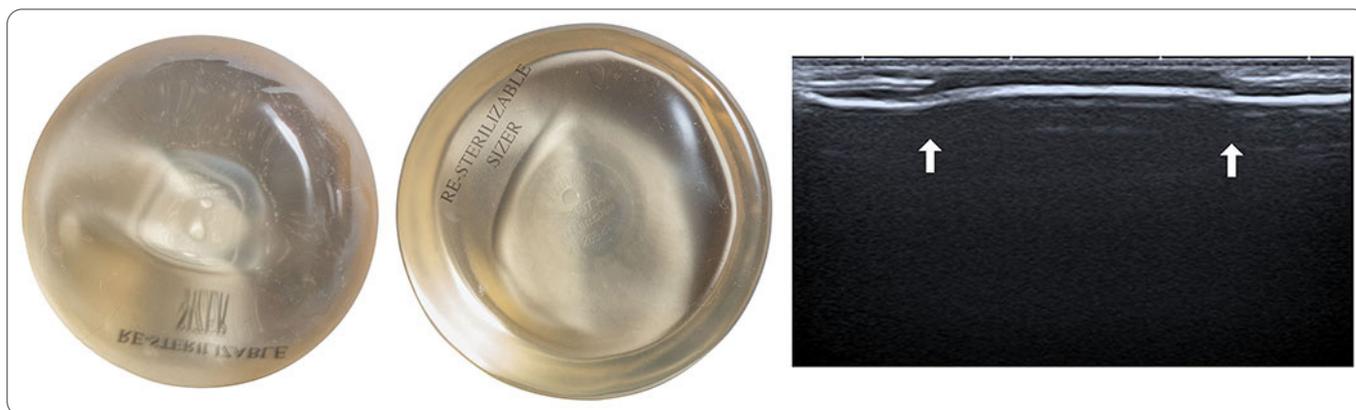
Figure 9. Allergan implant. Ultrasonographically there is rotation of the implant in a 180° axis. The posterior notch is identified as a horizontal echogenic line parallel to the implant capsule, which is apparently discontinuous. It looks like a focal and posterior thickening of the implant capsule.

1.2.4. Silicone seal in the posterior part of the implant or surface marker. The implants have a capsule made of a silicone elastomer that can vary from 1-2 mm. Most of them, when manufactured, have a hole of several centimeters in their posterior part that closes late once the implant lumen is filled. This patch, specific to each brand, is made of a thicker silicone elastomer that is adhered with a special silicone glue. Other implants are filled with a needle through the patch and the small hole is also closed with silicone glue. Normally this finding is not seen by ultrasound because it is small and very posterior, which is distorted with the ultrasound beam passing through the implant (4, 9) (figure 9).

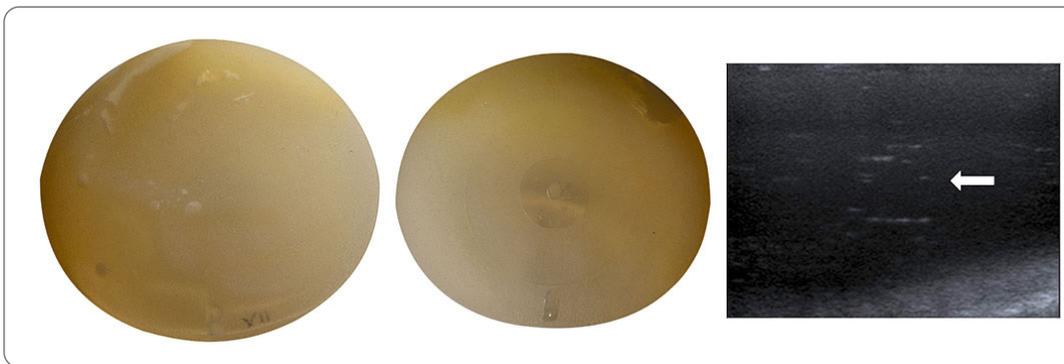
Figure 10. Macroscopically, bubbles are observed on the surface of the implants. Ultrasonographically they are observed as heterogeneity of the internal content of silicone and discontinuous intrasubstantial echogenic punctate foci.

1.3.3. Deterioration of the internal substance of the implant. Cilotti and collaborators have observed heterogeneity of the silicone content as discontinuous intrasubstantial echogenic punctiform foci. They do not indicate intracapsular rupture (Figure 10). Patients with this finding are clinically asymptomatic.

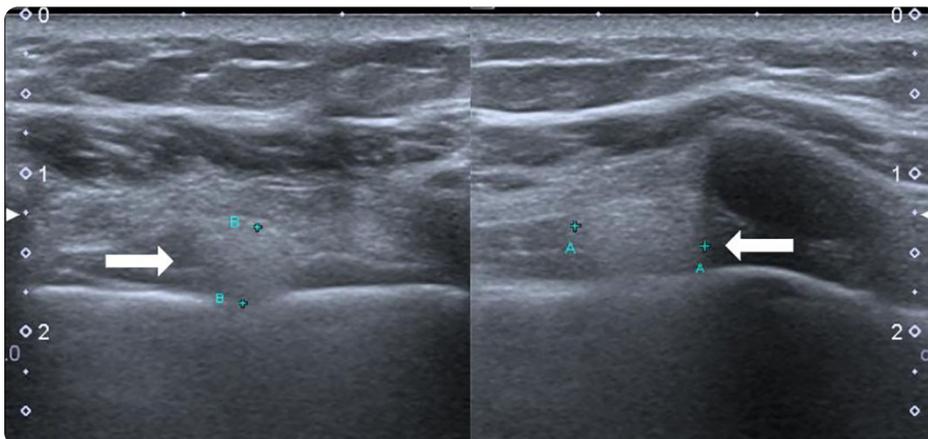
Figure 11. Extracapsular rupture. Ultrasound image of siliconoma in the internal mammary chain after implant rupture. Echogenic image with snowstorm appearance and poor definition of the posterior border. It is the same image for an intratissular siliconoma or in axillary nodes.

1.3.4. Gel bleed. It corresponds to a transudation of small and microscopic silicone molecules that go through the intact silicone capsule and the fibrous capsule, and migrate to the axillary ganglions by lymphatic way, in absence of rupture of the implant (5). They give the appearance of snowstorm (8, 15) (figure 11).

Ultrasonographically in an extracapsular rupture, signs of intracapsular rupture and the association of echogenic intramammary or axillary masses with loss of posterior detail of the silicone or echogenic posterior noise are observed, known as “snowstorm” image, in addition to hypoechogenic masses associated with echogenic noise around them (10,17). The “snowstorm” sign has a sensitivity of 85.7% and a specificity of 100% (14) and it is possible that the appearance of this sign is related to the amount of silicone in the mass or in the lymph node (15) (figure 11).

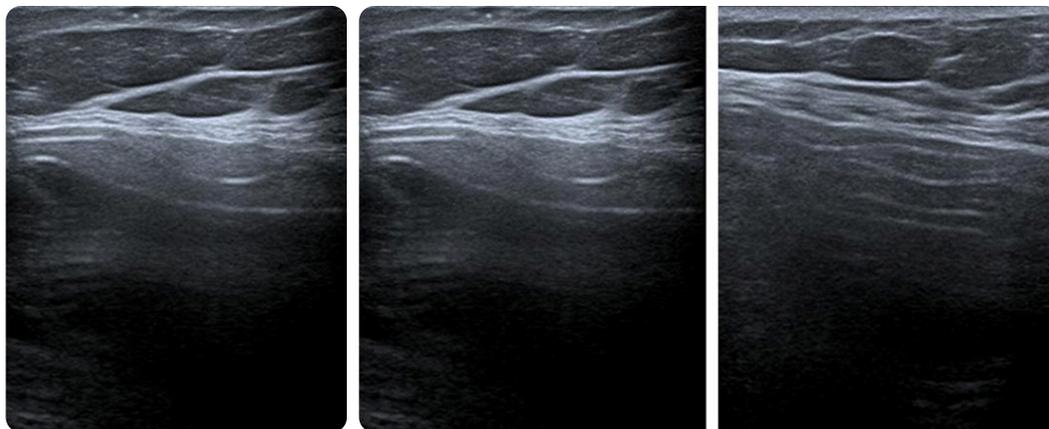
Figure 12. Intracapsular rupture. In the image on the left, loss of implant integrity with parallel wavy echogenic lines within the implant lumen due to capsular rupture and echogenic silicone contained within the external layer of the implant (white arrow). The image on the right shows the “ladder” sign.

In an intracapsular rupture, an irregular morphology with loss of continuity of the implant is observed in the ultrasound, with undulating echogenic lines that represent parts of the capsule floating inside the silicone and mobile echogenic silicone between the two layers of the implant (10). Heterogeneity of the internal substance with the “ladder” sign, which are linear, multiple and discontinuous echoes in the lumen, without filtration to axillary nodes (10) (figure 12).
